Manhole Inspection Summary

Manhole # S37S__051MH

Insp Date: **1/28/08 2:10 PM**

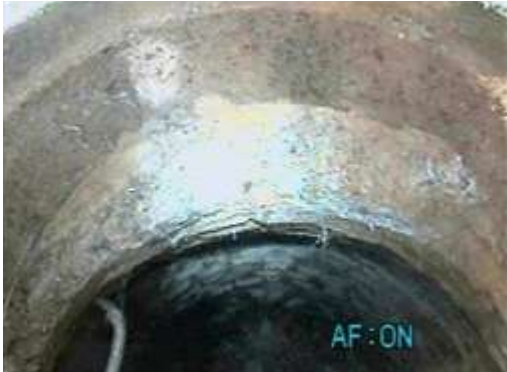
Defect 2

Frame Offset: **2** (in.) Condition: ☒ Sound ☐ Cracked ☐ Leaks

offset

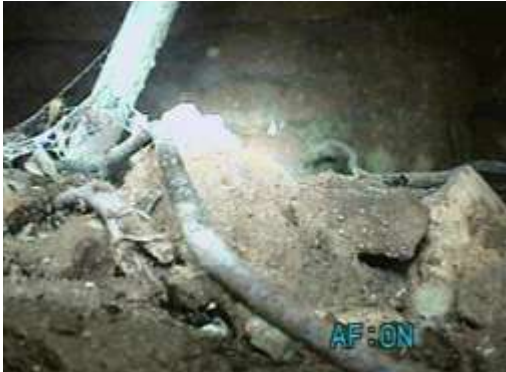
Defect 1

Condition: ☐ Sound ☐ Cracked ☐ Root Intrusion ☐ Deteriorated ☐ Leaks ☒ **Debris**

channel debris

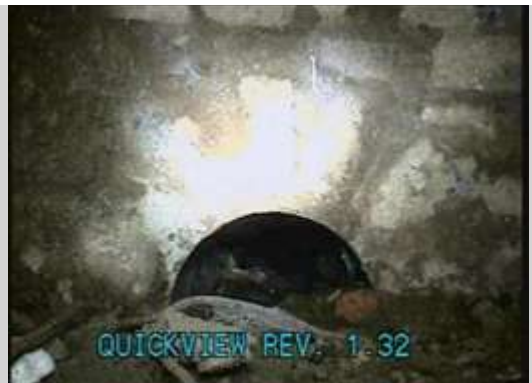
12 O'Clock Outflow

8 in. Circular Gravity Sewer
Pipe Out @ 12 O'Clock

Deposits: ☐ None ☐ Mud ☐ Sludge ☒ **Debris** ☐ Grease

Silt Depth: **3** (in.) Deposits Extent: **Medium**
